# Hyalomatrix®

## Frostbite case

21 year-old man with severe frostbite to the lower limbs, due to an accident in the Argentinean Andes, where he remained at high altitudes for several days. (Fig 1)

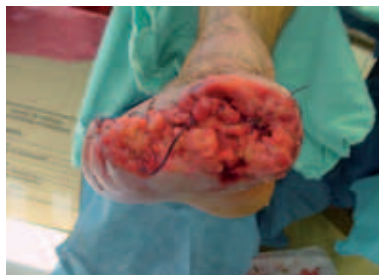
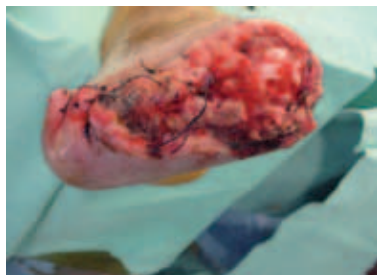
### DAY 1

**Fig 2 & 3:** The frostbite required the removal of the necrotic tissue and amputation of the toes 30 days post rescue. As a result, bones and joints at the amputation plane were particularly exposed. Hyalomatrix® was applied in order to protect such structures from desiccation, while a neo-tissue naturally developed on top of exposed bones and joint remnants.

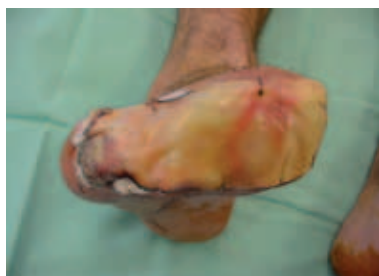
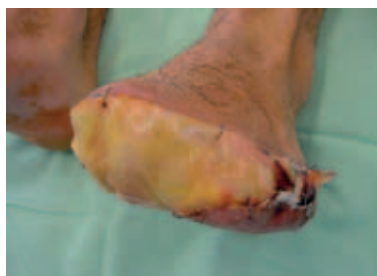
### DAY 6

**Fig 4 & 5:** Integration of the HYAFF® matrix during the healing phase.

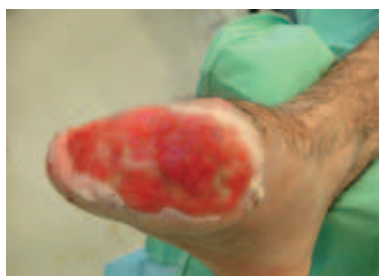
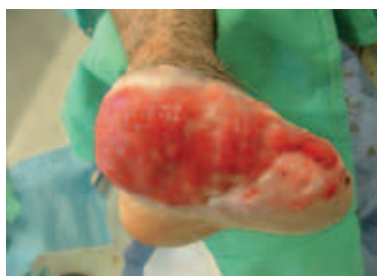
### DAY 10

**Fig 6 & 7:** Removal of the protective film. The HYAFF layer acted as scaffold for cellular invasion and capillary growth. Proper wound management with Hyalomatrix allowed for an appropriate bed to support the split-thickness skin graft.

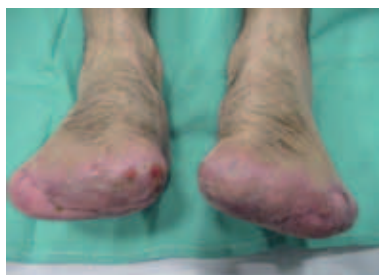
### DAY 20

**Fig 8:** Taking of the skin grafts and complete healing at day 10 post grafting.

**In this case, Hyalomatrix was an optimal wound management choice for a post-surgical lesion, allowing the application of a skin graft in 10 days.**
